# Bathymetric Surveys at Highway Bridges Crossing the Missouri and Mississippi Rivers near St. Louis, Missouri, 2010

Scientific Investigations Report 2011–5170

By Richard J. Huizinga

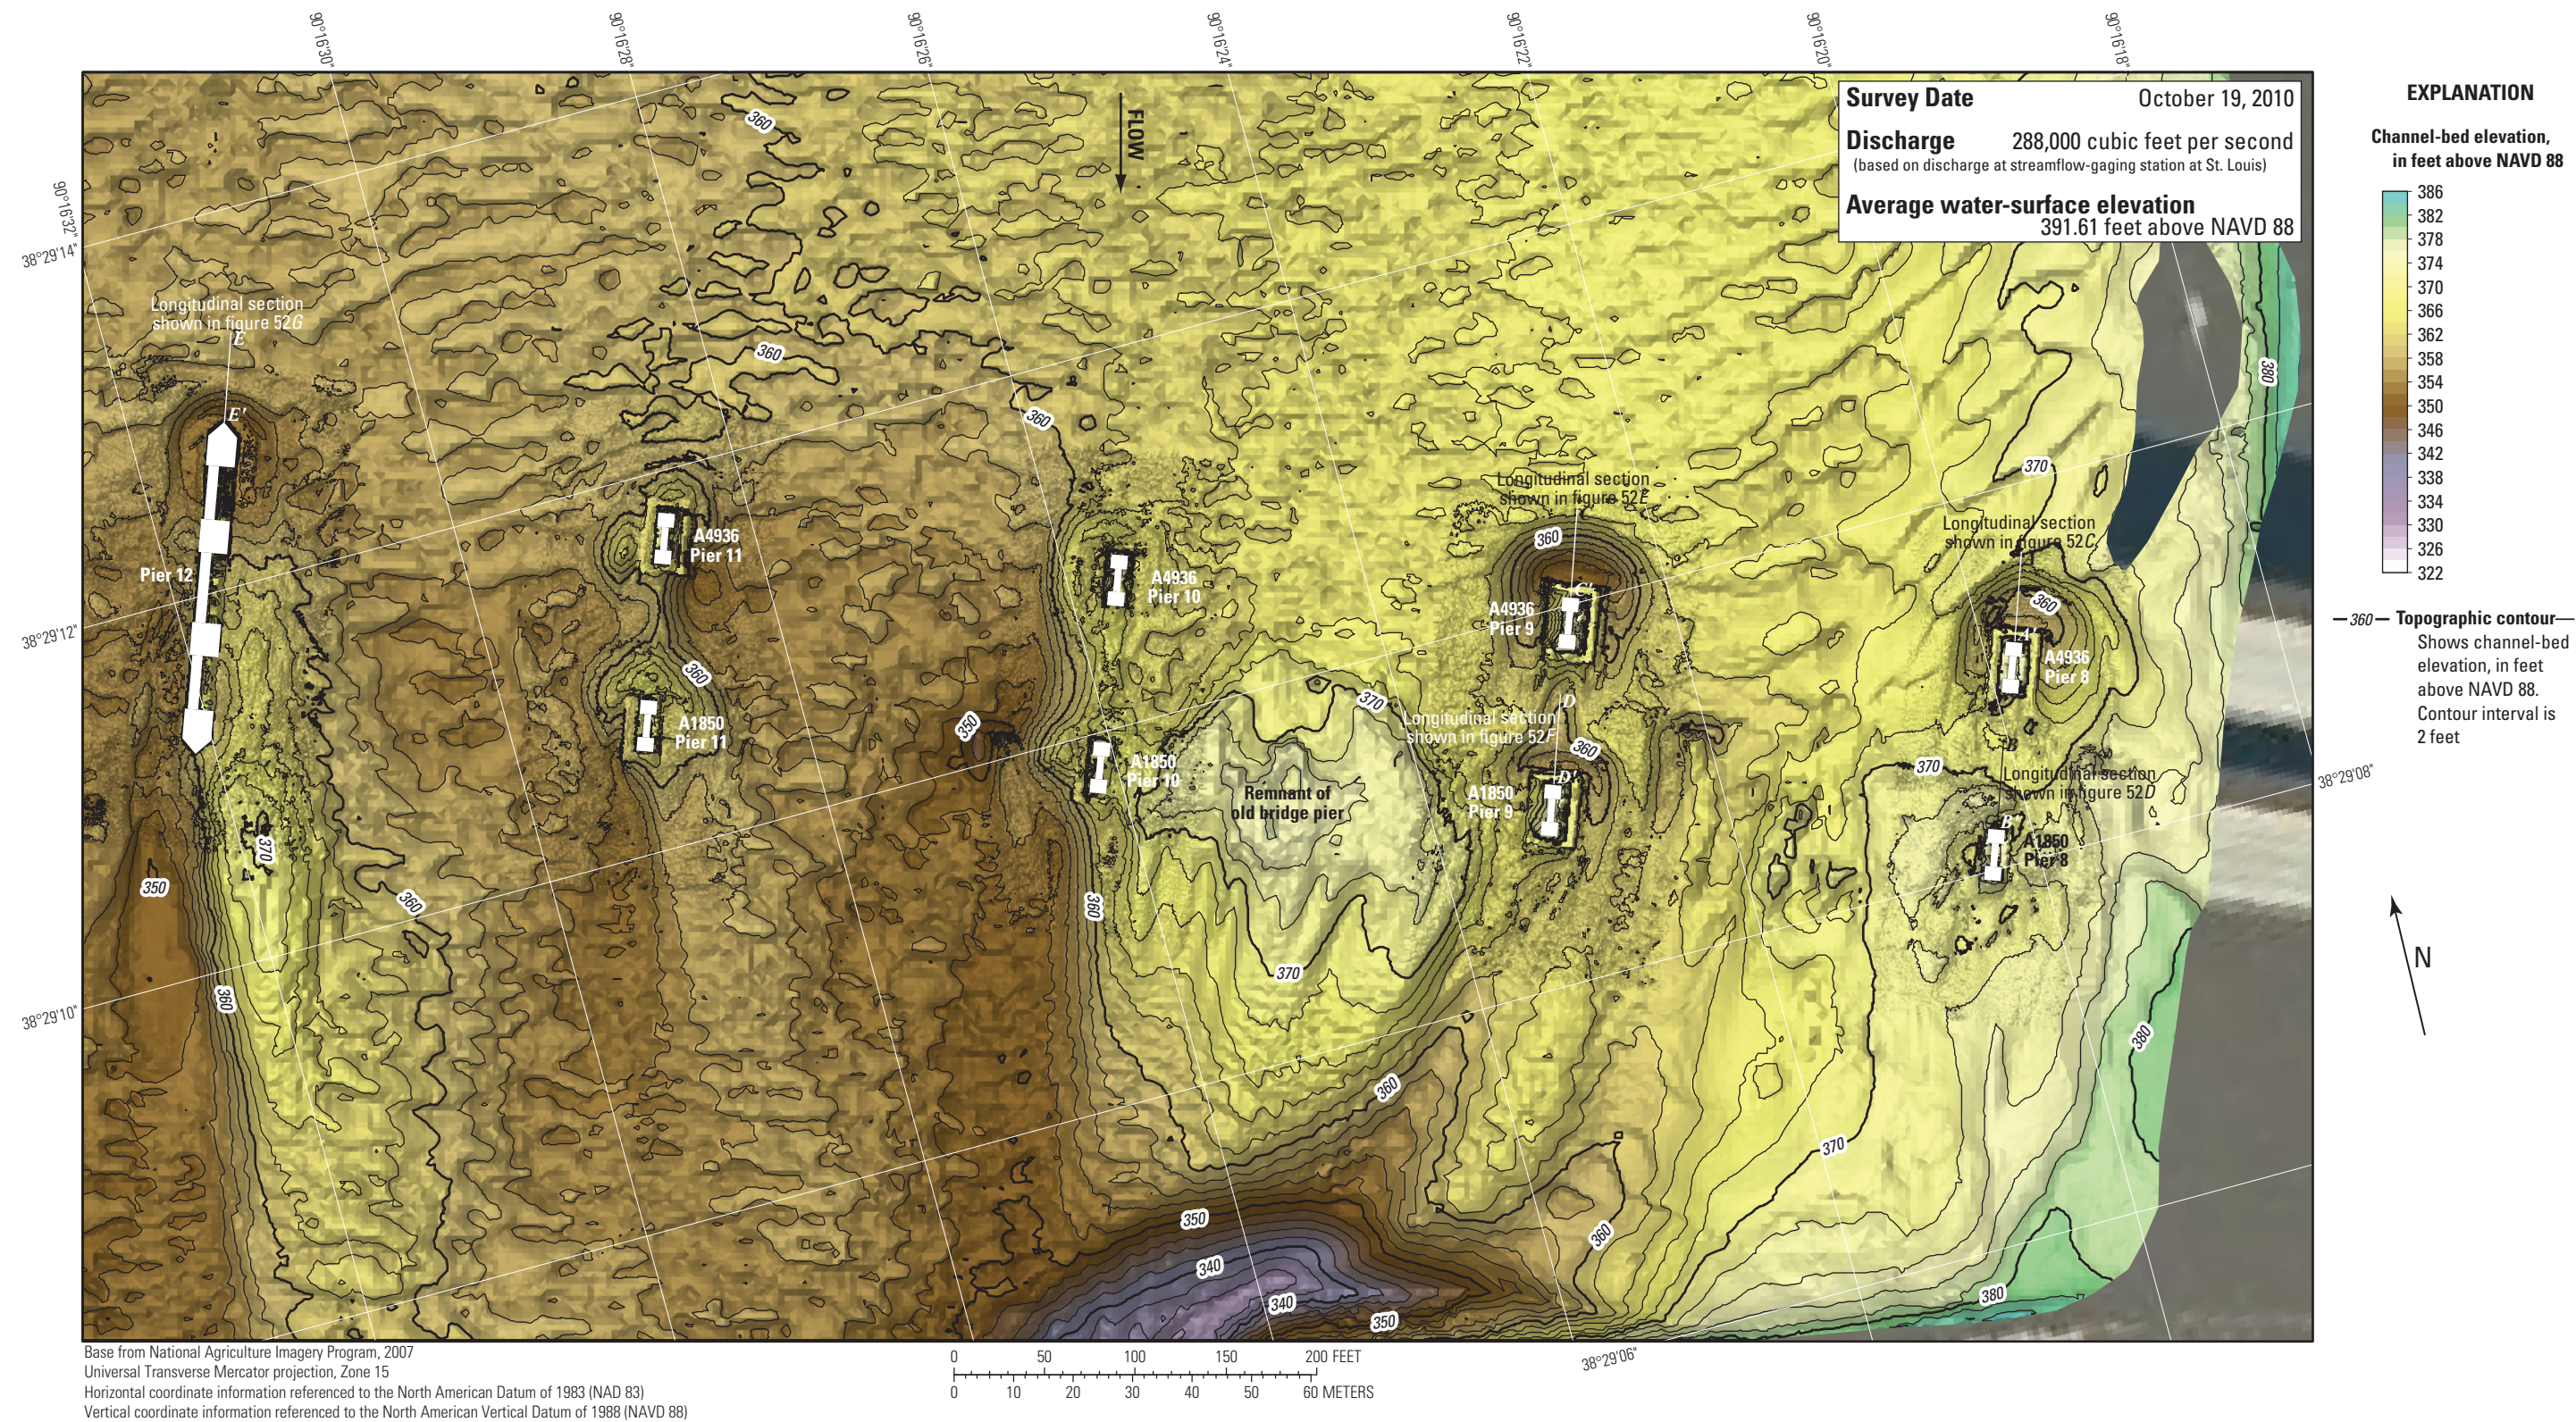
Figure 43. Bathymetric survey of the Mississippi River channel in the vicinity of the main channel piers of structures A4936 and A1850 on Interstate 255 near St. Louis, Missouri.

Substantial scour holes were present in the vicinity of piers 8 and 9 of upstream structure A4936, and moderate scour holes were present in the vicinity of piers 8 and 9 of downstream structure A1850 (fig. 43). Near pier 8 of upstream structure A4936, the scour hole had a minimum elevation of about 357 ft, about 13 ft below the average channel bed immediately upstream from the pier, and 4 ft above the bottom of the seal course elevation of 353.00 ft (fig. 43; table 7). Near pier 9 of upstream structure A4936, the scour hole had

a minimum elevation of about 350 ft, about 16 ft below the average channel bed immediately upstream from the pier, and 3 ft below the bottom of the seal course elevation of 353.00 ft (fig. 43; table 7). At downstream structure A1850, the scour hole near pier 8 had a minimum elevation of 368 ft (about 5 ft below the average channel bed immediately upstream), and the scour hole near pier 9 had a minimum elevation of 355 ft (about 9 ft below the average channel bed immediately upstream). Information from bridge plans indicates that structures A4936 and A1850 are exactly the same in cross section for the part of the bridges across the main channel, which permits the cross-section data for each bridge to be examined together (fig. 44). Bridge plans indicate that piers 8 and 9 are founded on piles driven to refusal on bedrock at both structures, and there is about 60 ft of bed material between the bottom of the scour hole and bedrock at pier 8 of upstream structure A4936 and about 53 ft of bed material between the bottom of the scour hole and bedrock at pier 9 of upstream structure A4936 (fig. 44; table 7). A point cloud visualization of the multibeam depth points obtained during the survey clearly show the exposed footing and seal course of pier 9 of both structures A4936 and A1850 (fig. 45).

A moderate scour hole was present upstream from pier 12 with a minimum elevation of about 350 ft, about 9 ft below the average channel bed immediately upstream from the pier, but 22 feet above the bottom of the seal course elevation of 328.00 ft (fig. 43; table 7). Information from bridge plans indicates that pier 12 is founded on piles driven to refusal on bedrock, with about 55 ft of bed material between the bottom of the scour hole and bedrock (fig. 44; table 7). A point-cloud visualization of the multibeam-depth points obtained during the survey shows the top of the exposed footing of pier 12 (fig. 46).

Scour holes were not observed upstream from piers 10 and 11 of either structure A4936 or A1850 (fig. 43); in fact, the surveyed channel bed appears to be aggraded in the vicinity of these piers (fig. 44), which indicates riprap or some other scour-resistant material has been piled near the upstream faces of these piers; however, the side edges and downstream corners of the footings are apparent at pier 11 of both structures, and a local scour hole with a minimum elevation of 351 ft was present near the downstream left corner of pier 11 of upstream structure A4936. The remnant of an old bridge pier was observed between piers 9 and 10 of downstream structure A1850 (figs. 43, 44).

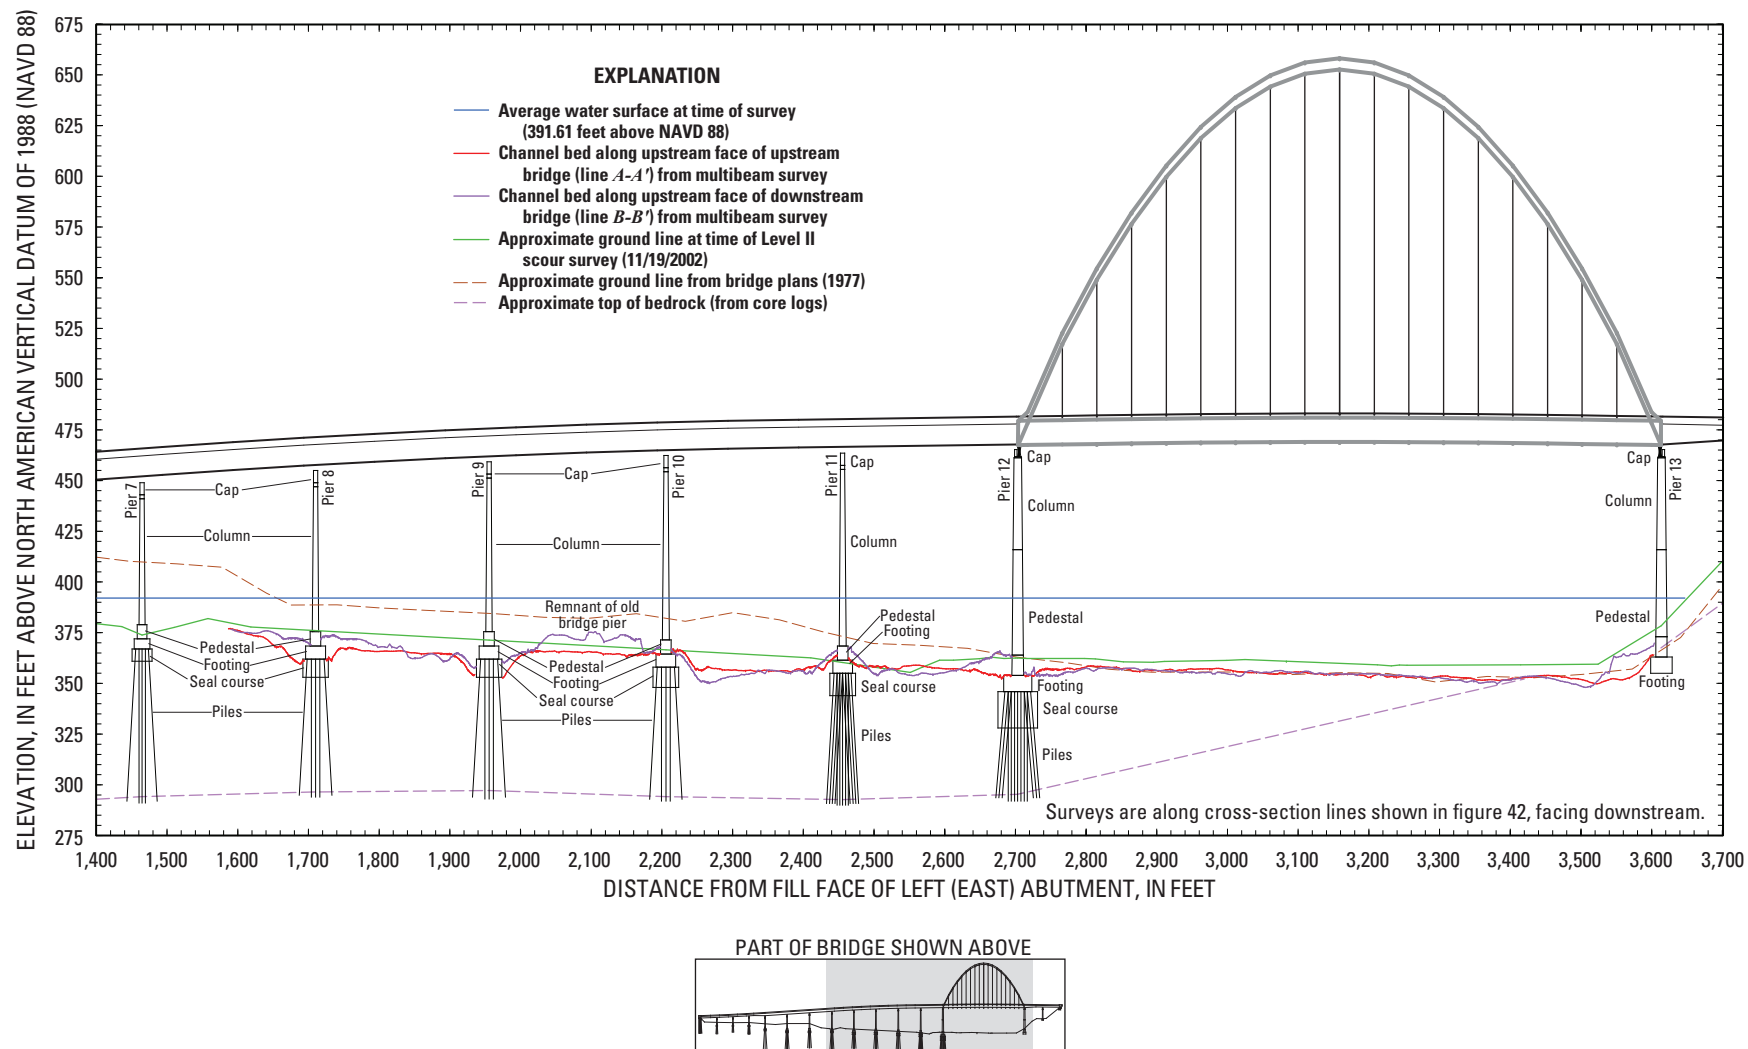
**Figure 44.** Key features, substructural and superstructural details, and surveyed channel bed along the upstream face of each bridge of identical structures A4936 and A1850 on Interstate 255 over the Mississippi River near St. Louis, Missouri.

The surveyed channel bed was approximately 5 ft lower than the channel bed from the Level II scour survey in November 2002 (Huizinga and Rydlund, 2004) for most of the channel, except between piers 8 and 9, and between piers 10 and 11 (fig. 44). In the main channel between piers 12 and 13, the surveyed channel bed was essentially the same as the ground line from bridge plans at the time of construction in 1977 (fig. 44).

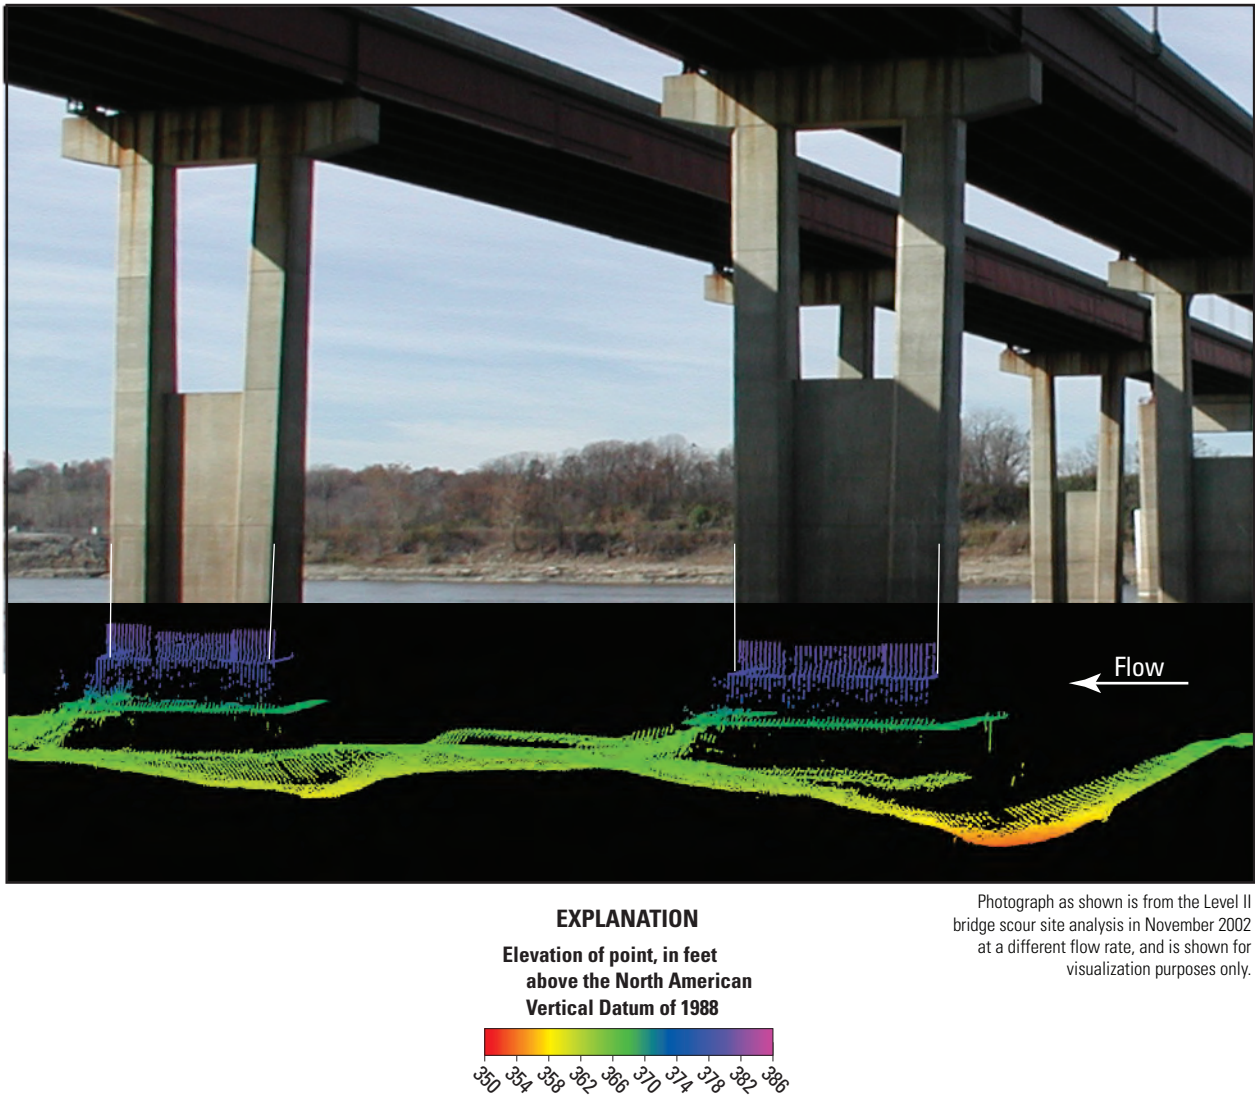
**Figure 45.** Point cloud visualization of the channel bed and left (east) side of main channel pier 9 of structures A4936 and A1850 on Interstate 255 over the Mississippi River near St. Louis, Missouri.

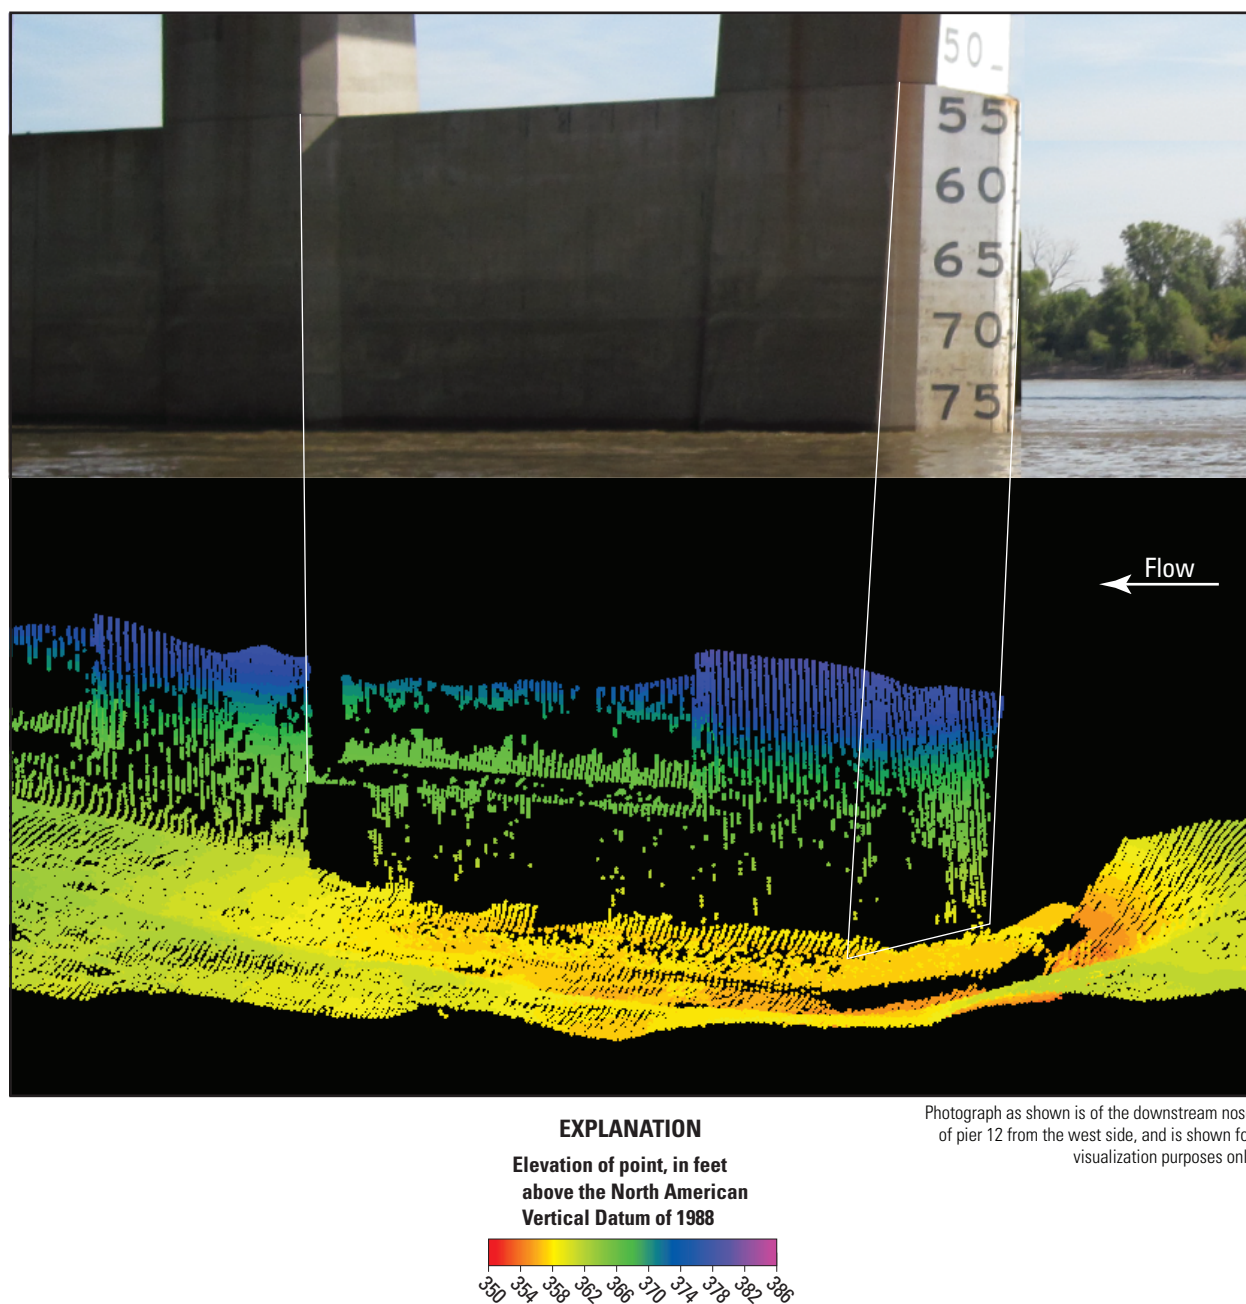
**Figure 46.** Point cloud visualization of the channel bed and left (east) side of main channel pier 12 of structures A4936 and A1850 on Interstate 255 over the Mississippi River near St. Louis, Missouri.

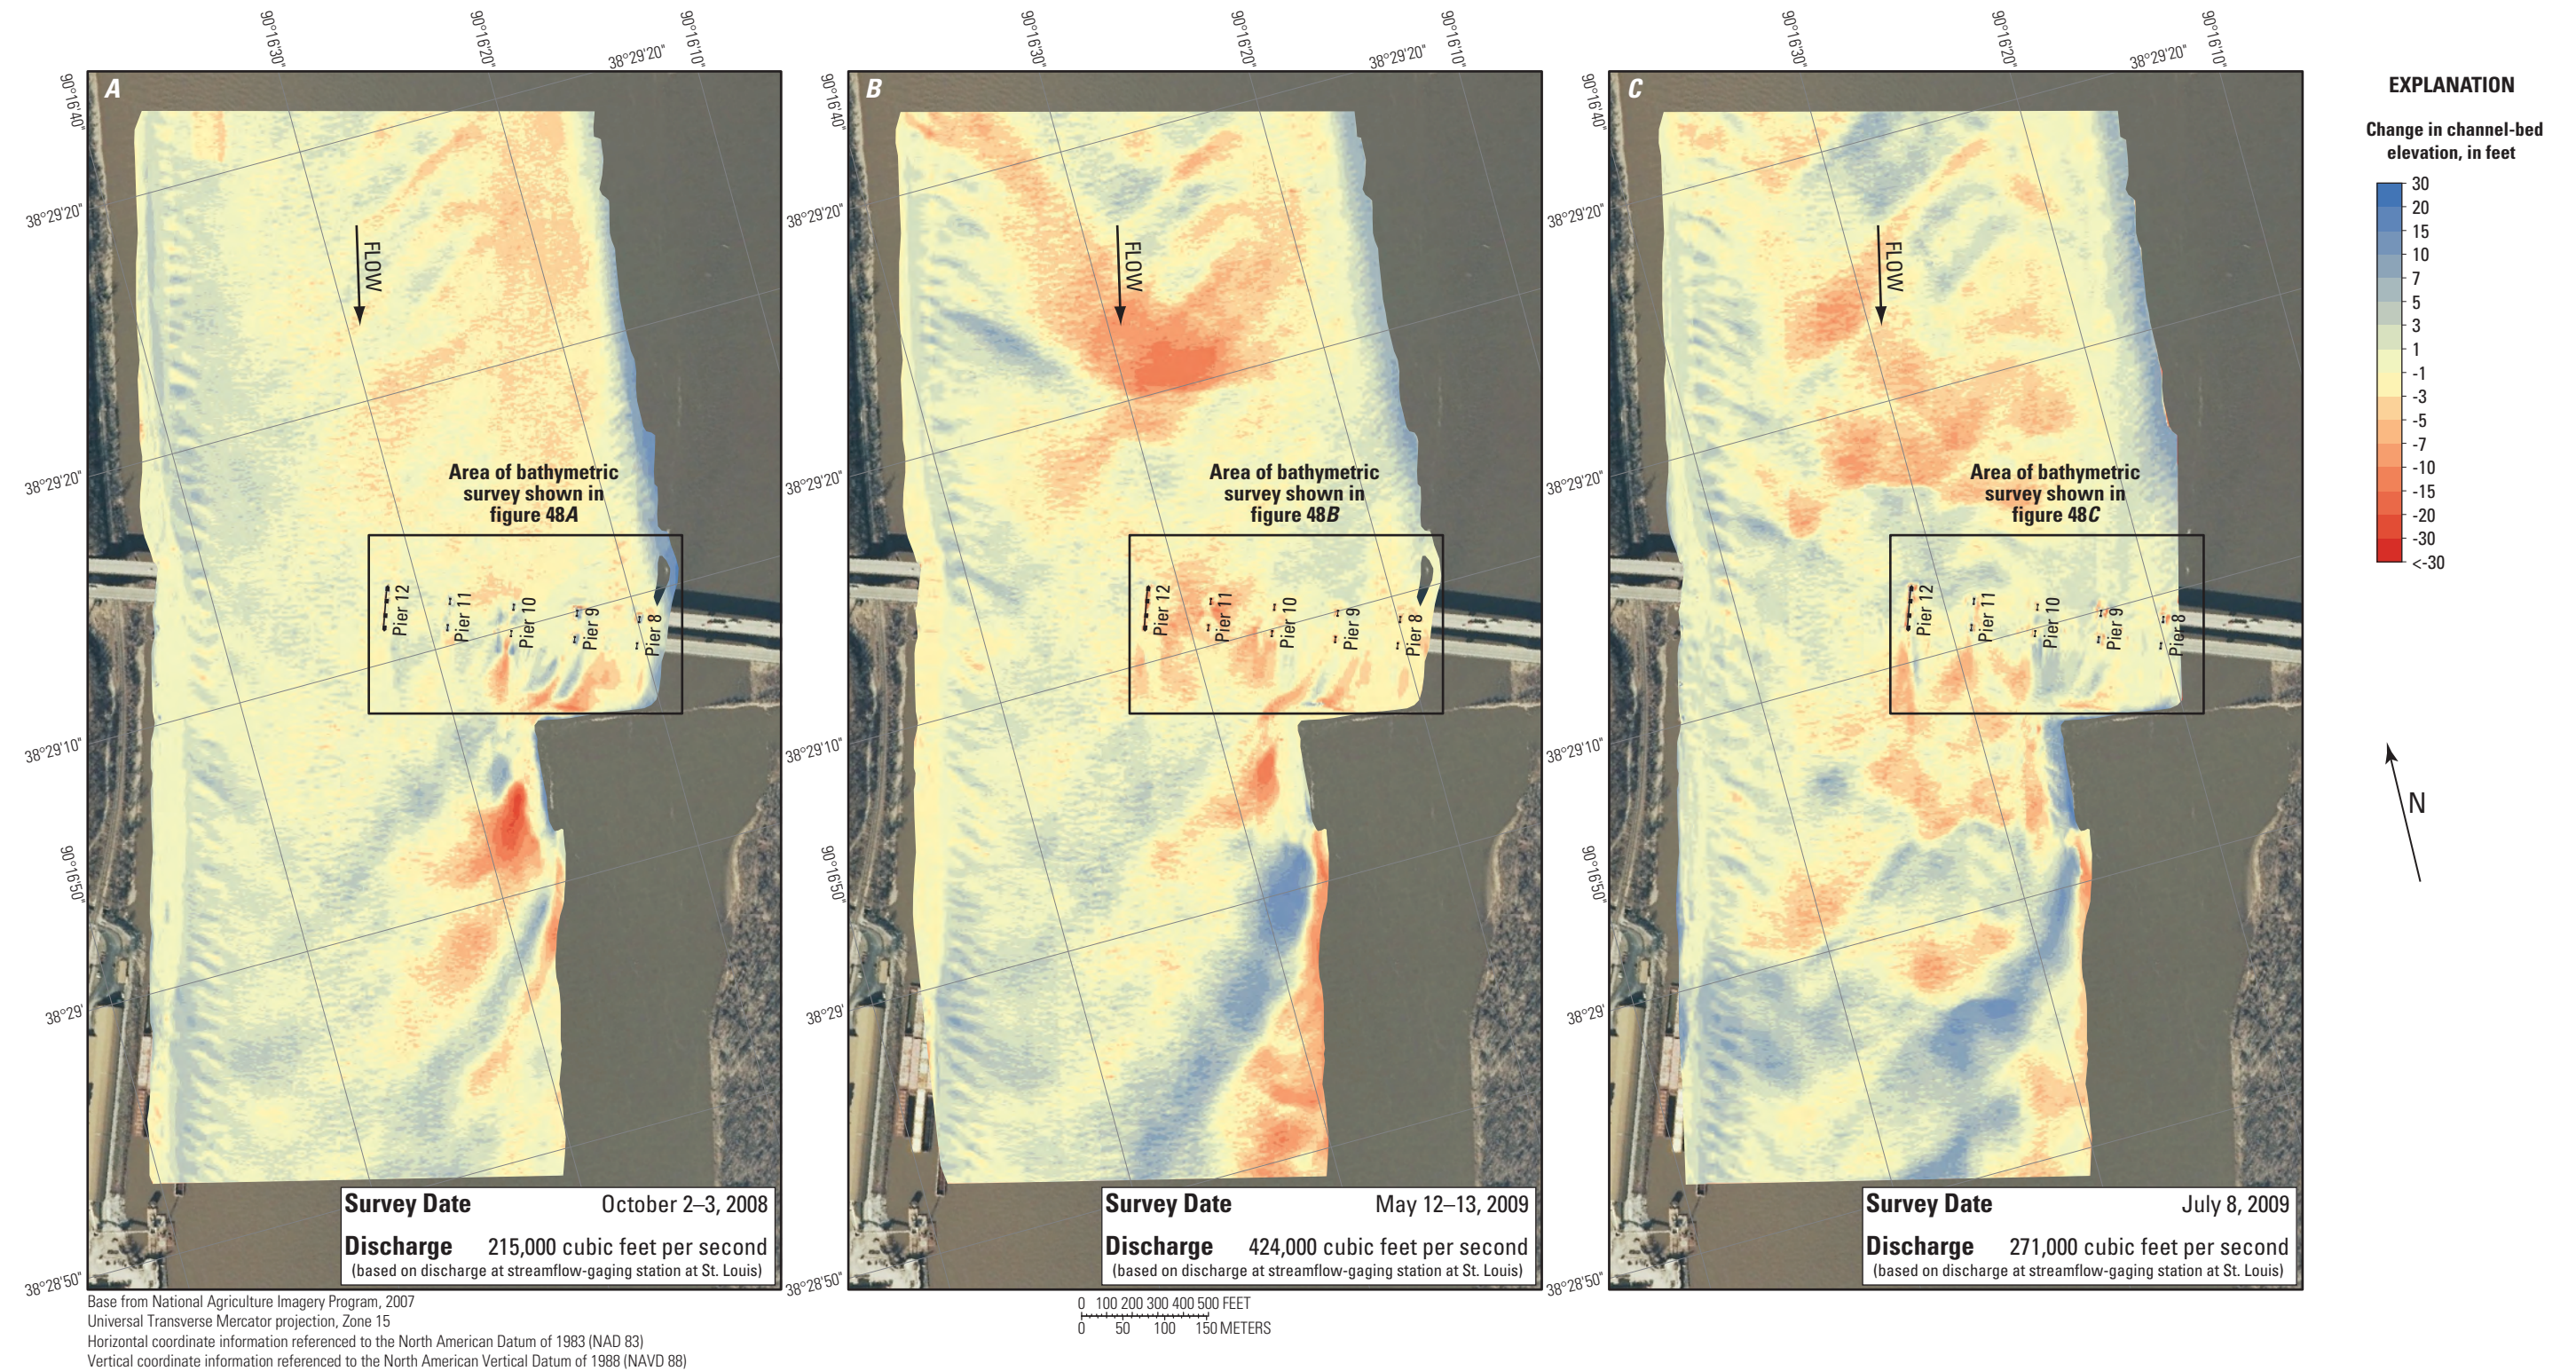
The change in channel-bed elevation between the scans on October 19, 2010, and May 12–13, 2009 (fig. 47B), also indicates several local areas of scour and deposition corresponding to the dune features observed during the May 12–13, 2009, scan, particularly the large dune observed in the channel upstream from the bridge (Rydlund, 2009). This dune was roughly 10–15 ft tall in May 2009, and movement of this large dune feature likely corresponds to the nearly 5-ft pulse captured by the fixed transducer on the downstream pier nose in mid-June 2009 (Rydlund, 2009). The localized deep scour hole adjacent to the L-head dike in the October 19, 2010, scan (fig. 42) extended further downstream in May 2009 because of minor flooding at that time, resulting in substantial deposition observed downstream from the downstream tip of the L-head

dike on the left bank (fig. 47B). This deposition had not yet occurred by the July 2009 scan, resulting in a similar deposition pattern for that scan (fig. 47C).

The change in channel-bed elevation between the scans on October 19, 2010, and October 2–3, 2008 (fig. 47A), indicates the channel bed had resumed a configuration similar to that observed in October 2008. No substantial channel bed changes were observed with the fixed transducer on the upstream pier nose from October to December 2008, and no changes were observed with the downstream transducer from October 2008 to early June 2009 (Rydlund, 2009). The channel thalweg was slightly deeper in October 2008, resulting in minor deposition along the right side of the channel and minor degradation along the upstream left side of the channel (fig. 47A). Substantial deposition had occurred in the shallow area on the extreme left side of the survey area between October 2008 and October 2010 (fig. 47A). The enlargement of the localized scour hole adjacent to the L-head dike in May 2009 persisted through the October 2010 scan, resulting in the area of substantial scour indicated near the dike (fig. 47A).

**Figure 47.** Difference between bathymetric survey of the Mississippi River channel in the vicinity of structures A4936 and A1850 on Interstate 255 near St. Louis, Missouri, on October 19, 2010, and bathymetric surveys on *A*, October 2–3, 2008, *B*, May 12–13, 2009, and, *C*, July 8, 2009.

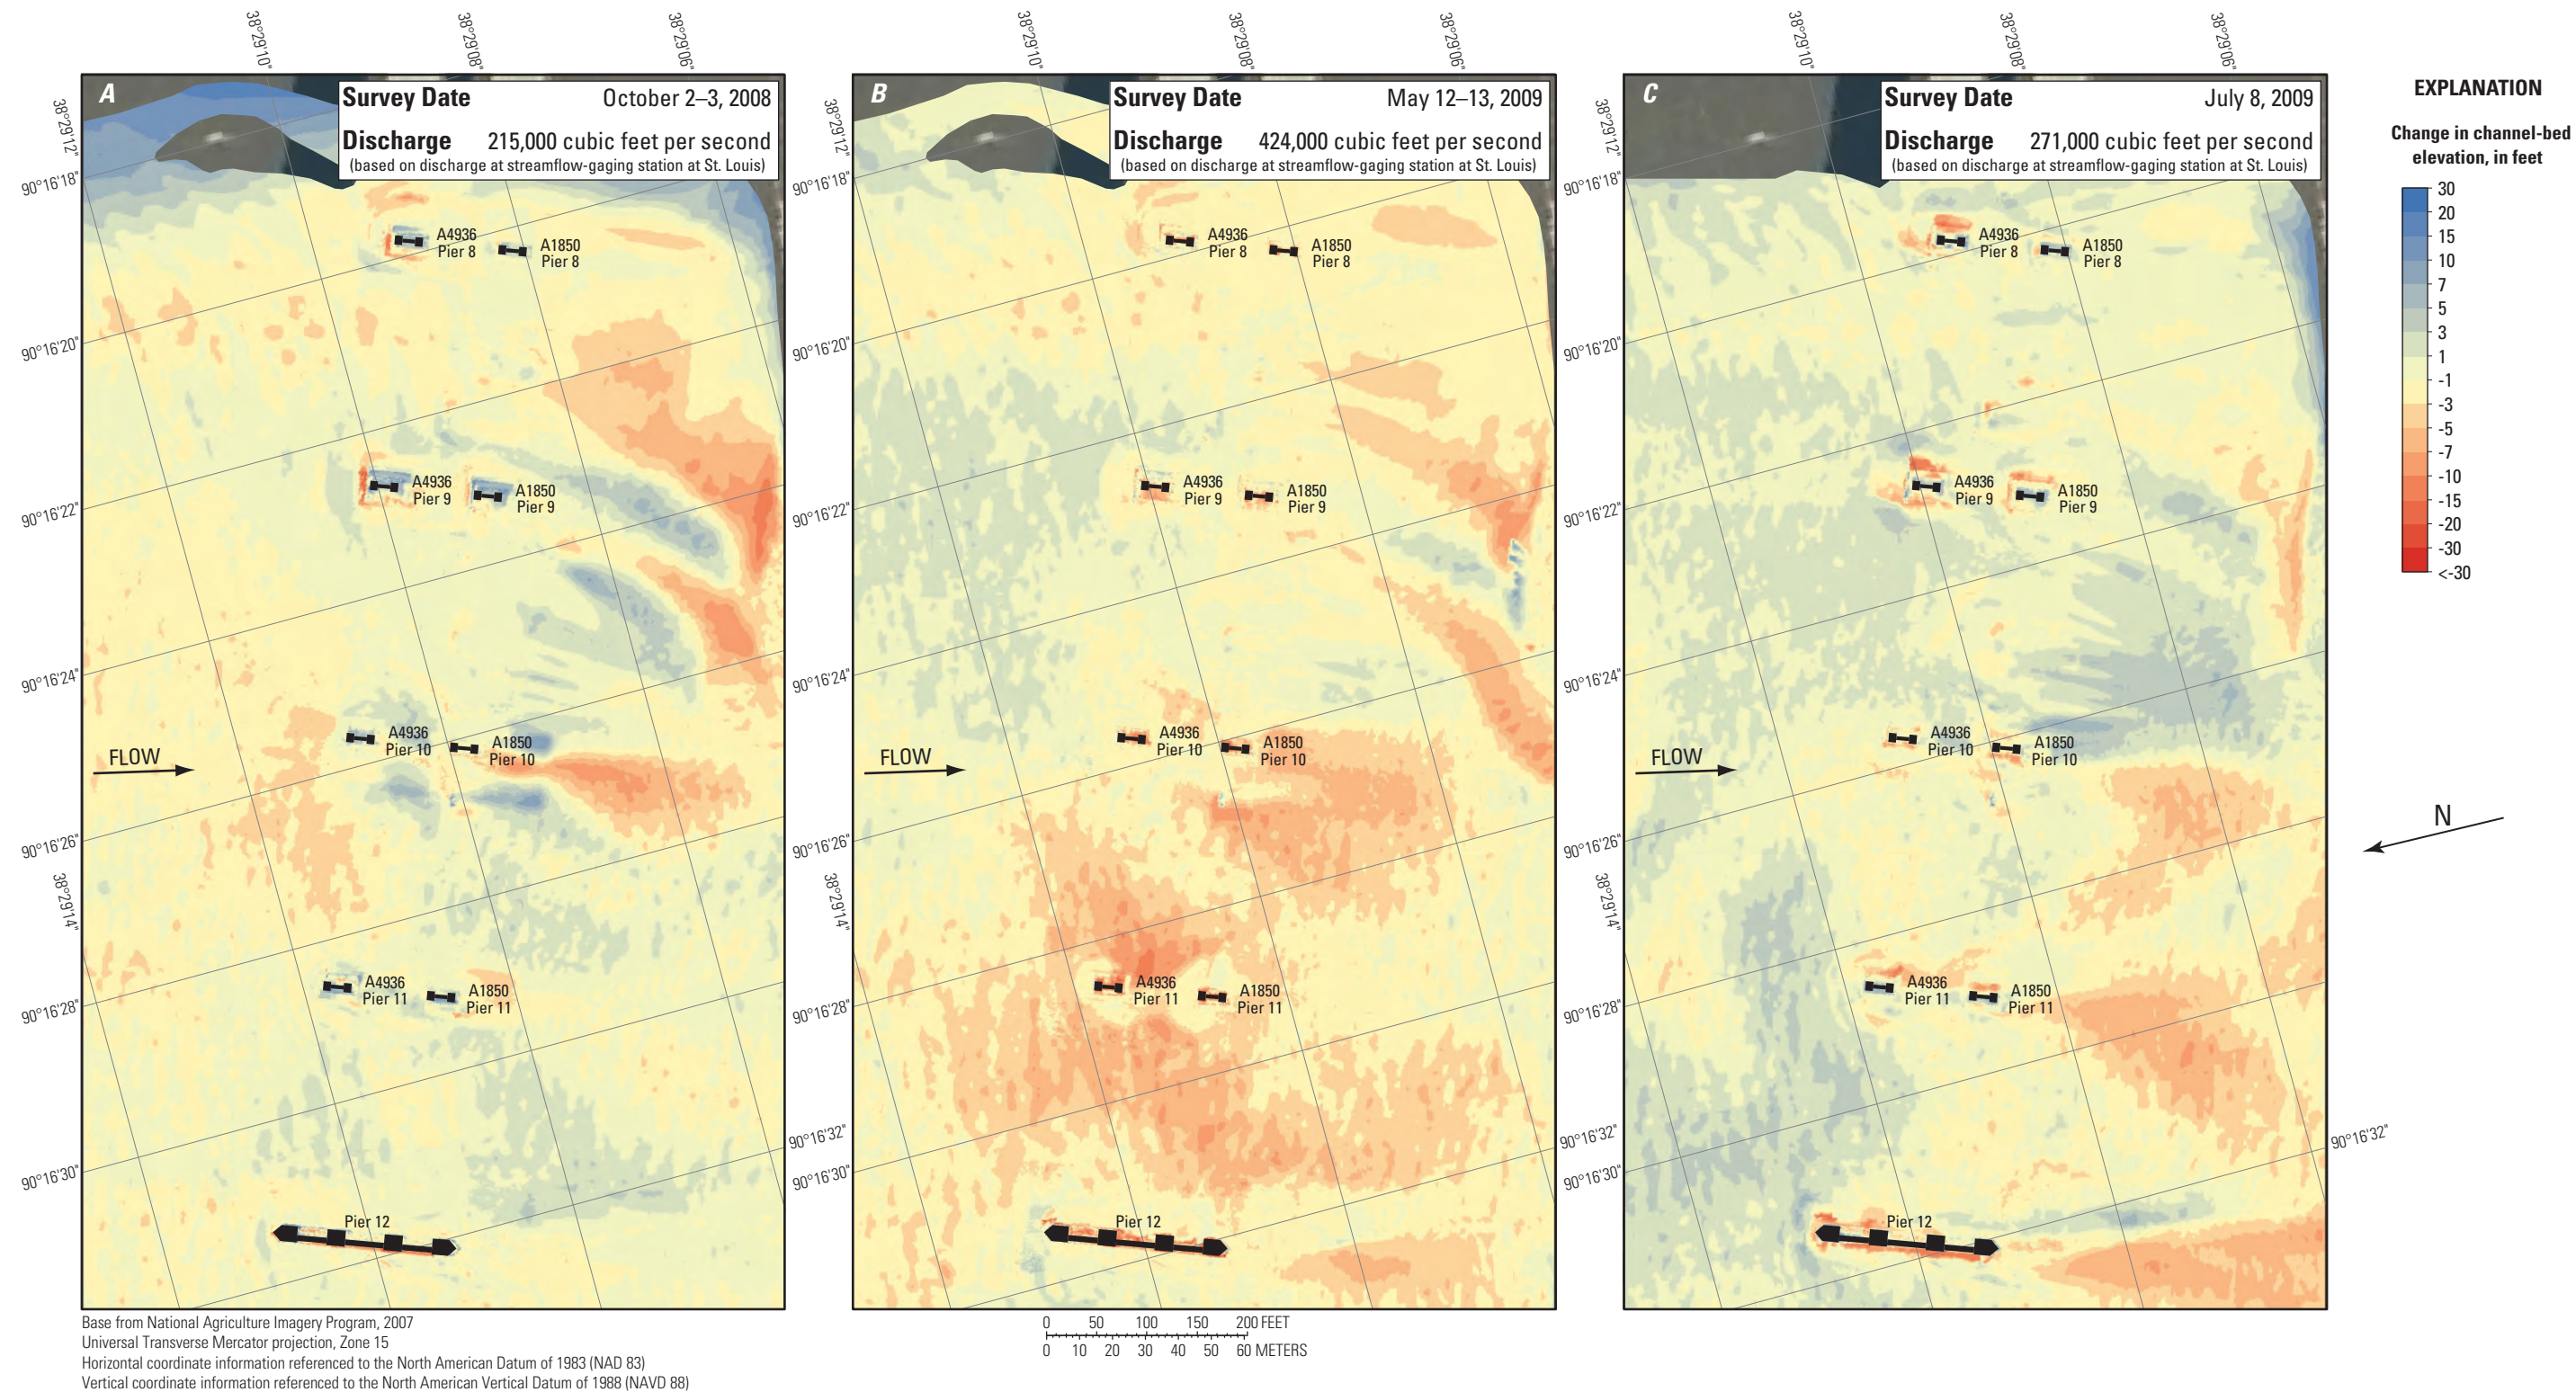
Comparison of the surveyed channel in the vicinity of the main channel piers on different dates revealed some areas where the channel bed remained the same through time, and other areas where the channel bed changed through time (fig. 48). The similarity of the channel-bed configuration is obvious between the scans on October 19, 2010, and October 2–3, 2008 (fig. 48A). The substantial deposition on the left bank is apparent, as well as minor deposition and erosion in the immediate vicinity of piers 8, 9, and 10; however, the bed changes in the vicinity of the piers may be caused by positional errors, as there was no correction of the survey lines for the first two surveys (Oct 2–3, 2008, and May 12–13, 2009). The change in channel-bed elevation between the scans on October 19, 2010, and May 12–13, 2009, indicates nearly 9 ft of erosion had occurred in the vicinity of piers 10 and 11 between these scans (fig. 48B). The lack of bed-elevation change in the immediate vicinity of pier 11 further substantiates the presence of riprap or some other scour-resistant material around this pier, although there is more change in the immediate vicinity of this pier between the October 19, 2010, and July 8, 2009, scans (fig. 48C). A comparison of the cross sections along the upstream bridge face for the four scans indicates the relative stability of the bed in the main channel between piers 12 and 13, as well as the substantial movement of the bed in the vicinity of pier 11 (fig. 49). Although the scour holes near piers 8 and 9 were somewhat wider in the scans of May 12–13 and July 8, 2009, they did not appear substantially deeper than the other scans (fig. 49).

**Figure 48.** Difference between bathymetric survey of the Mississippi River channel in the vicinity of the main channel piers of structures A4936 and A1850 on Interstate 255 near St. Louis, Missouri, on October 19, 2010, and bathymetric surveys on *A*, October 2–3, 2008, *B*, May 12–13, 2009, and *C*, July 8, 2009.

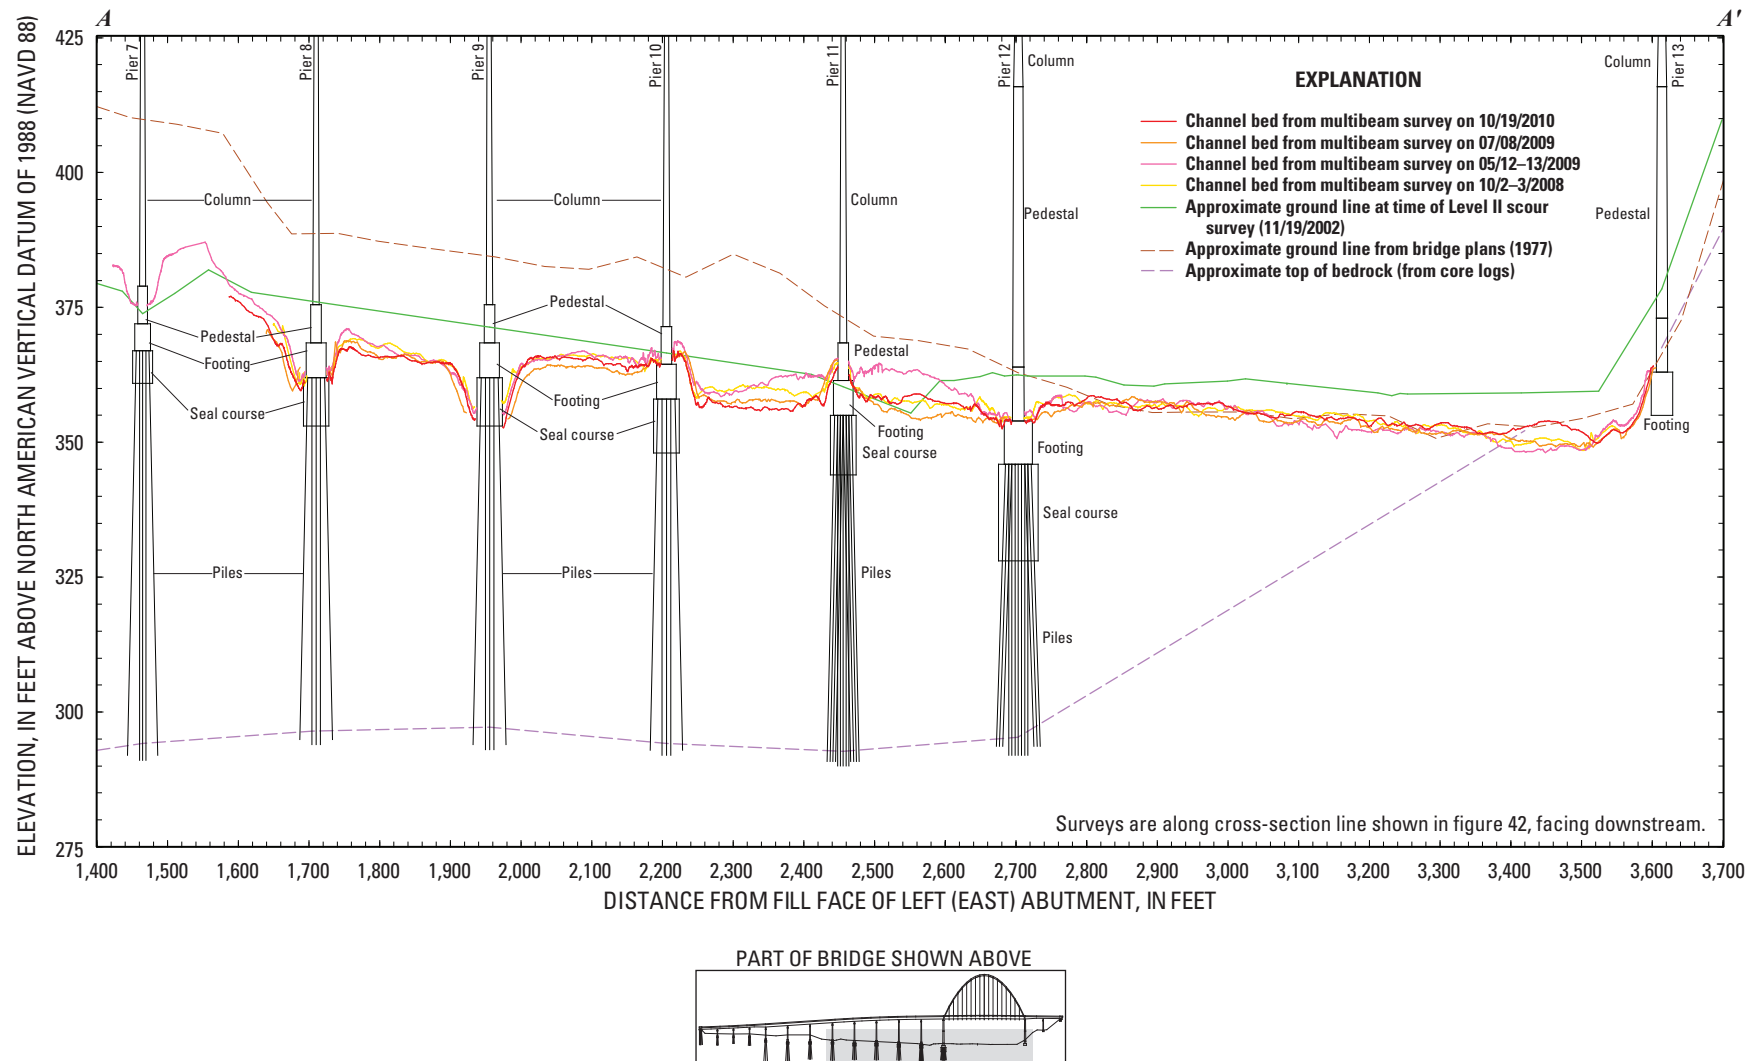
**Figure 49.** Key features, substructural and superstructural details, and surveyed channel bed along the upstream face of upstream structure A4936 on Interstate 255 over the Mississippi River near St. Louis, Missouri, from surveys on different dates.
